TECHNICAL REPORT ARCCB-TR-88041

**FRACTOGRAPHIC ANALYSIS  
OF A FAILED CRANE BOLT**

**A. A. KAPUSTA**

NOVEMBER 1988

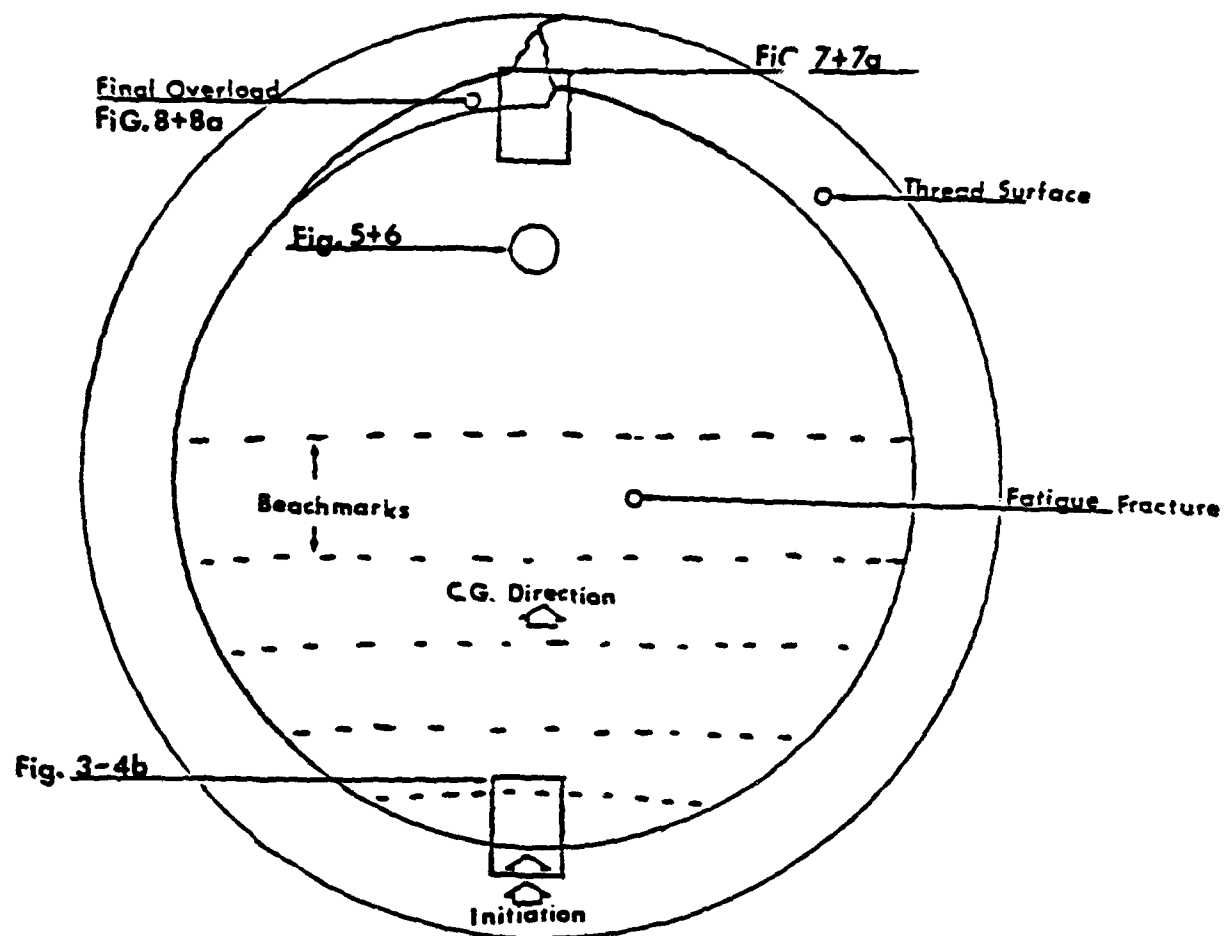
Viewing the fracture surface under oblique illumination revealed faint beach marks shown in Figure 1, indicative of initiation from a single site.

of a mode I tensile separation. Fatigue crack growth direction, determined from striation orientation, was consistent with crack initiation from a single site and subsequent propagation as noted in Figure 1.

Figure 1. Schematic of fracture surface.

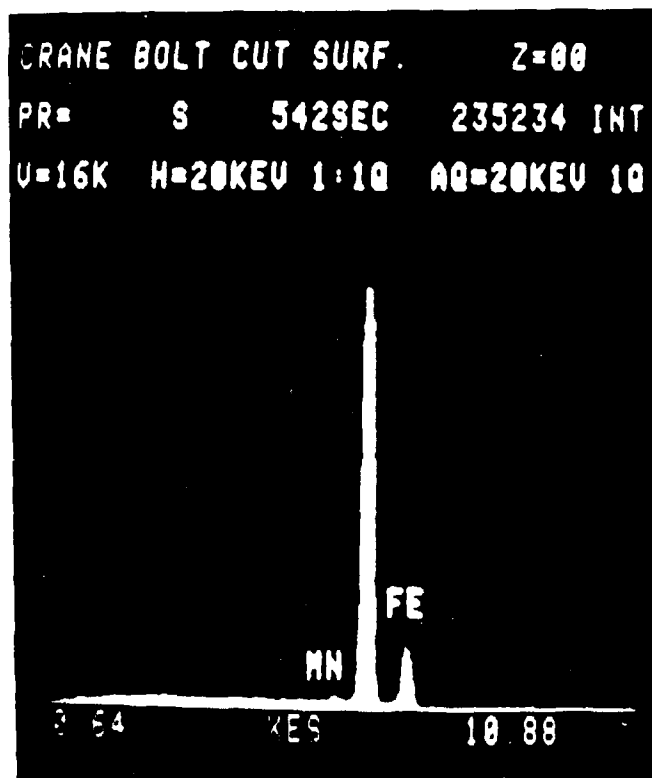
An EDX spectrum, Figure 2, from a "clean" cut surface of the bolt shows that it is made from plain steel.

Figure 2. Energy dispersive x-ray spectrum of crane bolt.

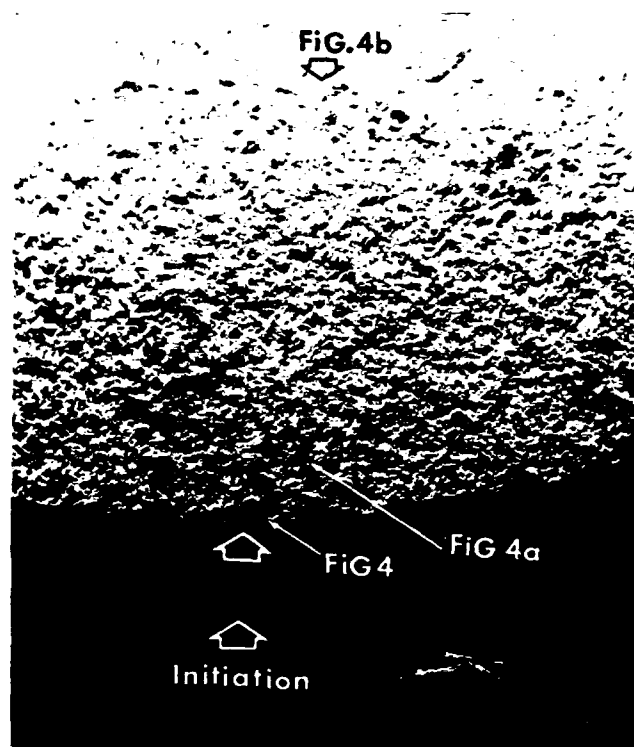
SEM, Figure 3, shows the initiation region, while Figure 4, at higher magnification shows this region to be free of any material defect. The fracture surface was essentially transgranular (Figures 4, 5, and 7), and stage II fatigue striations were found across its entire length (Figures 4a, 4b, 6, and 7a), except for the very small region labeled in Figure 1. This small region was all transgranular dimpled (Figure 8a) consistent with and indicative of final fast overload fracture. Most of these dimples were equiaxed, indicative

Figure 3. Fatigue fracture initiation as indicated by the white arrow (12X).

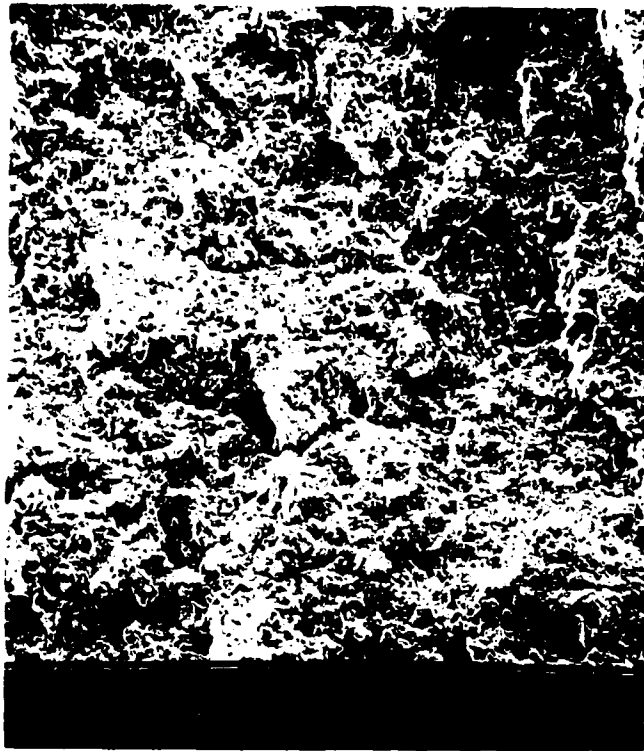
Figure 5. Fatigue fracture propagation (55X).

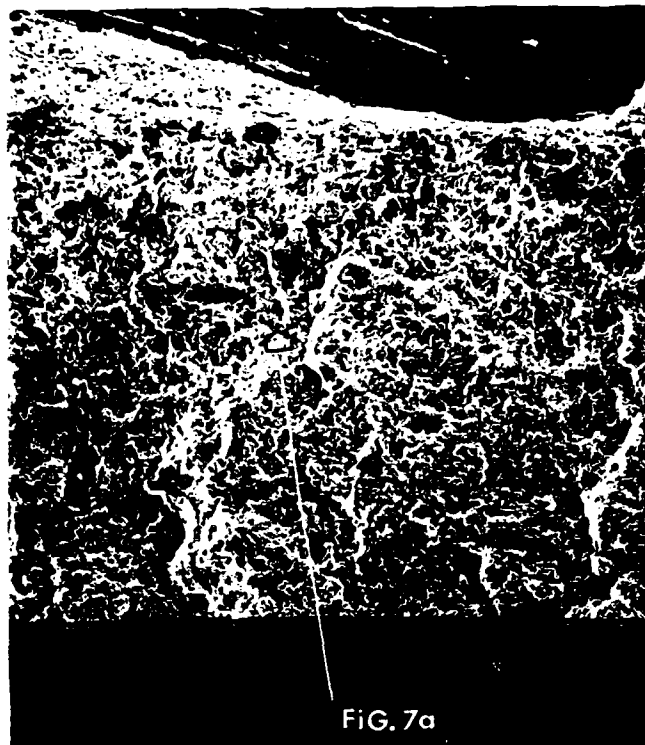
Figure 7. Fatigue fracture propagation (30X).

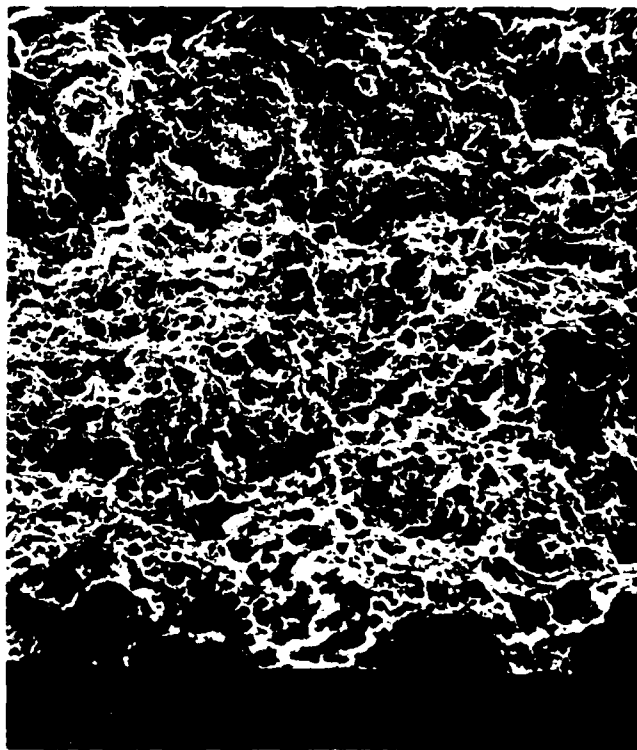
Figure 8. Final tensile overload separation (100X).

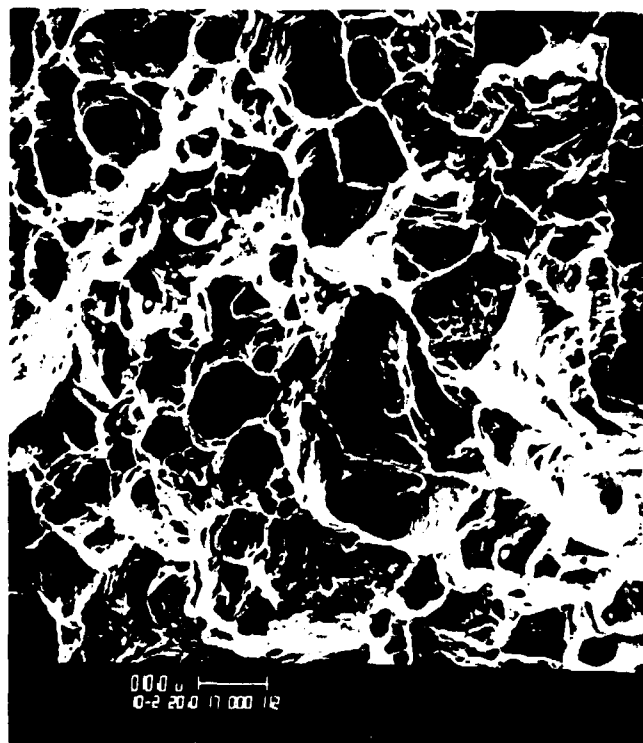
Figure 8a. Microvoid mode of fracture in final tensile overload (1000X).

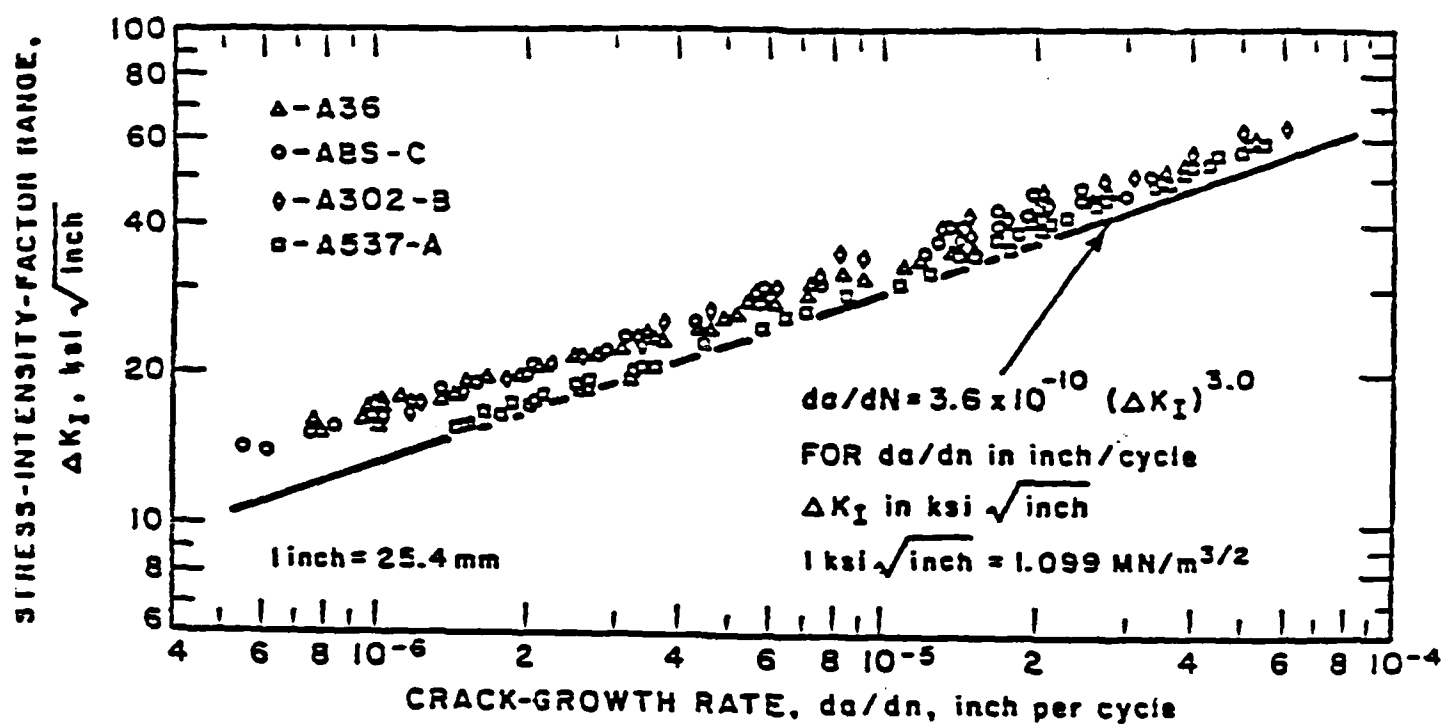
Of the several empirically derived fatigue crack growth rate (FCGR) versus  $\Delta K$  relationships in the literature, that shown in Figure 9 (ref 1) is relevant to this sample, since it was derived for ferrite/pearlite steels. Using the crack growth versus stress intensity plot in Figure 9, a  $\Delta K$  of  $\sim 34 \text{ Ksi}\sqrt{\text{in.}}$  was derived for this bolt.

4. Estimates of the acting  $\Delta K$  were made using the measured  $da/dN$  from the micrographs and FCGR- $\Delta K$  relationships in the literature for ferrite/pearlite steels. The acting  $\Delta K$  for this ferrite/pearlite bolt, from Figure 9, was calculated to be  $\sim 34 \text{ Ksi}\sqrt{\text{in.}}$ .

Figure 9. Fatigue crack growth data for pearlitic/ferritic steels (ref 1).
